SUSTAINABLE NAPIER COMMITTEE

Open Minutes Attachments

Meeting Date: Thursday 20 June 2024

Bay View Pipeline Break and Repair

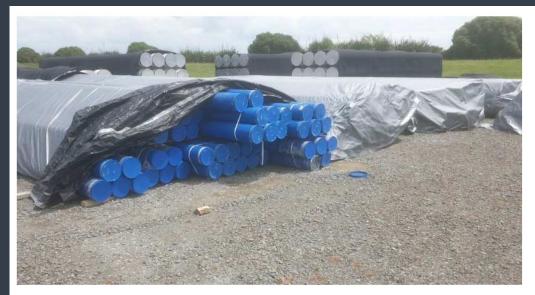
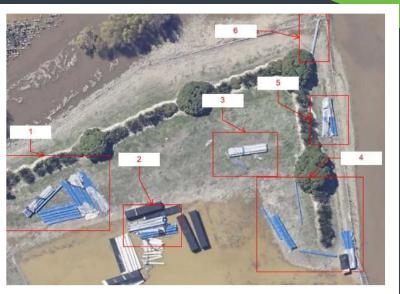
Figure 1: Watermains prior to Cyclone Gabriel (left) and post Cyclone Gabriel (right)

- Flushing
- Foam swabbing
- Chlorination
- Flushing
- Storing and Testing

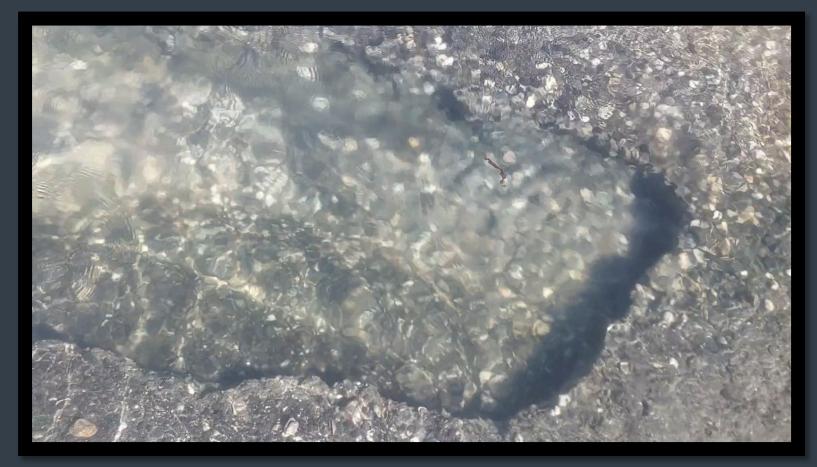
The Leak

Footage showing the exit point of the leak, into the estuary

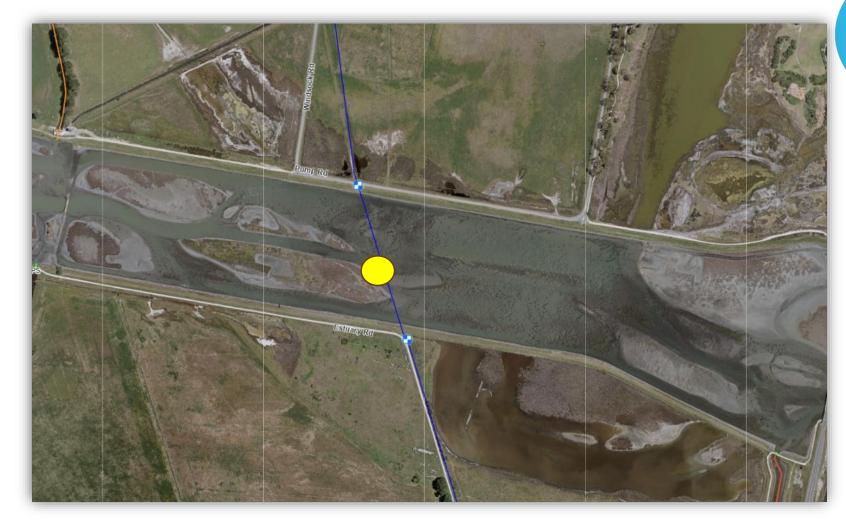
The Position

Aerial view of where the break occurred
