NAPIER
CITY COUNCIL
Te Kaunihera o Ahuriri

EXTRAORDINARY SUSTAINABLE NAPIER COMMITTEE

Open Agenda

Meeting Date: Thursday 17 February 2022

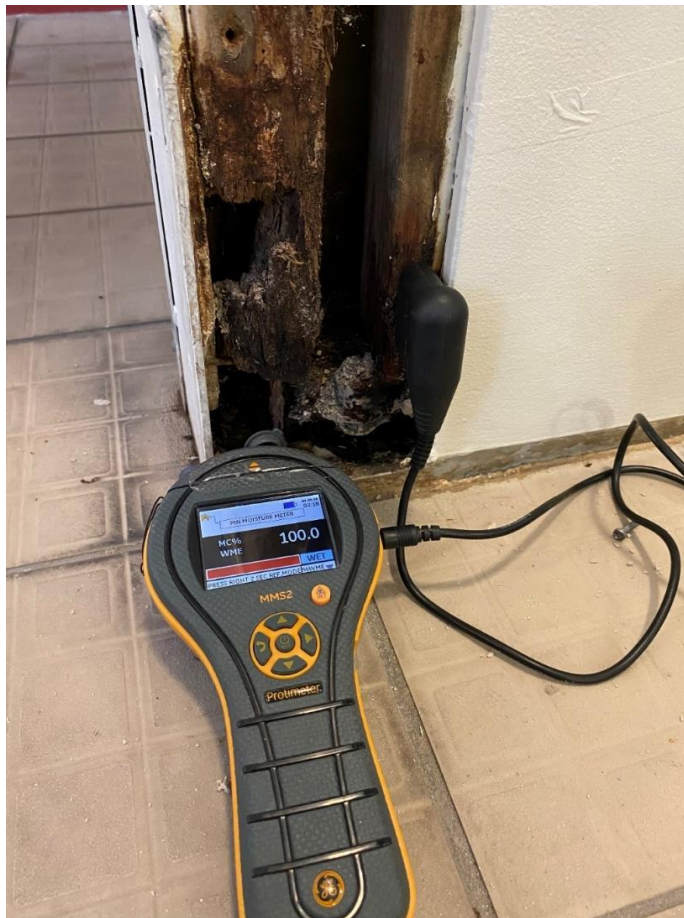
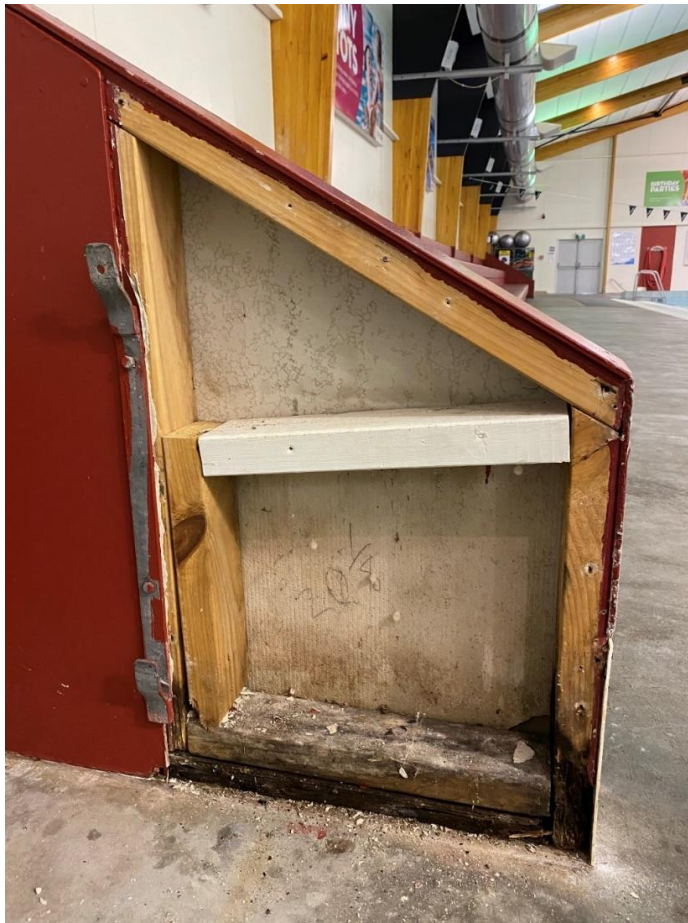
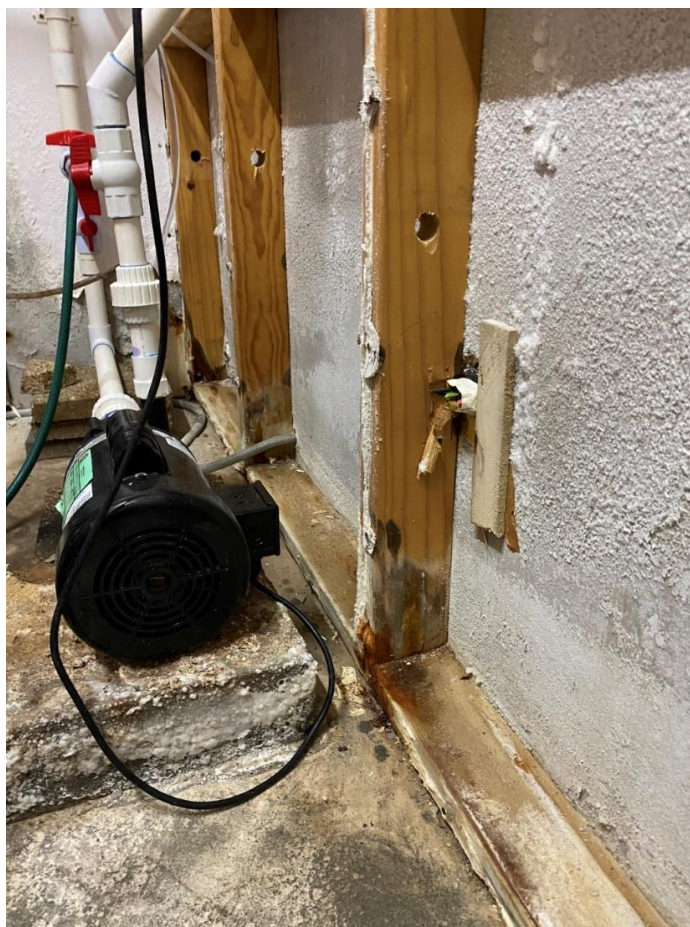
Why is it required?	Internal cladding and framing is seriously degraded due to 20 years of water ingress during cleaning
What are the recommendations?	<ul style="list-style-type: none"> ▪Site Prep/Demolition/Protection of Services etc ▪Concrete Nibs ▪Construction of New Walls/Linings ▪External Aluminium Joinery ▪Internal Doors ▪Strip Drain to Exterior Wall facing Splash Pad - 300mm wide
How much?	Remediation of internal walls \$3,417,742
Risks	<ul style="list-style-type: none"> ▪Moisture in the bottom plates has eroded fixings in places, resulting in compromised structural integrity
Source documents	NCC - NAC Internal Wall Condition Assessment – Dean & Quane (June 2021)

By far the item with the largest cost attached is the remediation of the internal walls of the Ivan Wilson complex, at an estimated cost of \$3.4 million. Mould was found present on the base plates and lower parts of the studs most of the areas that were surveyed. Subsequent testing revealed no presence of *Stachybotrys* (Black Mould), but high levels of an unidentified dematiaceous fungus. The presence of this unidentified dematiaceous fungus is the reason that the internal wall remediation is included within the health and safety and legislative compliance category.

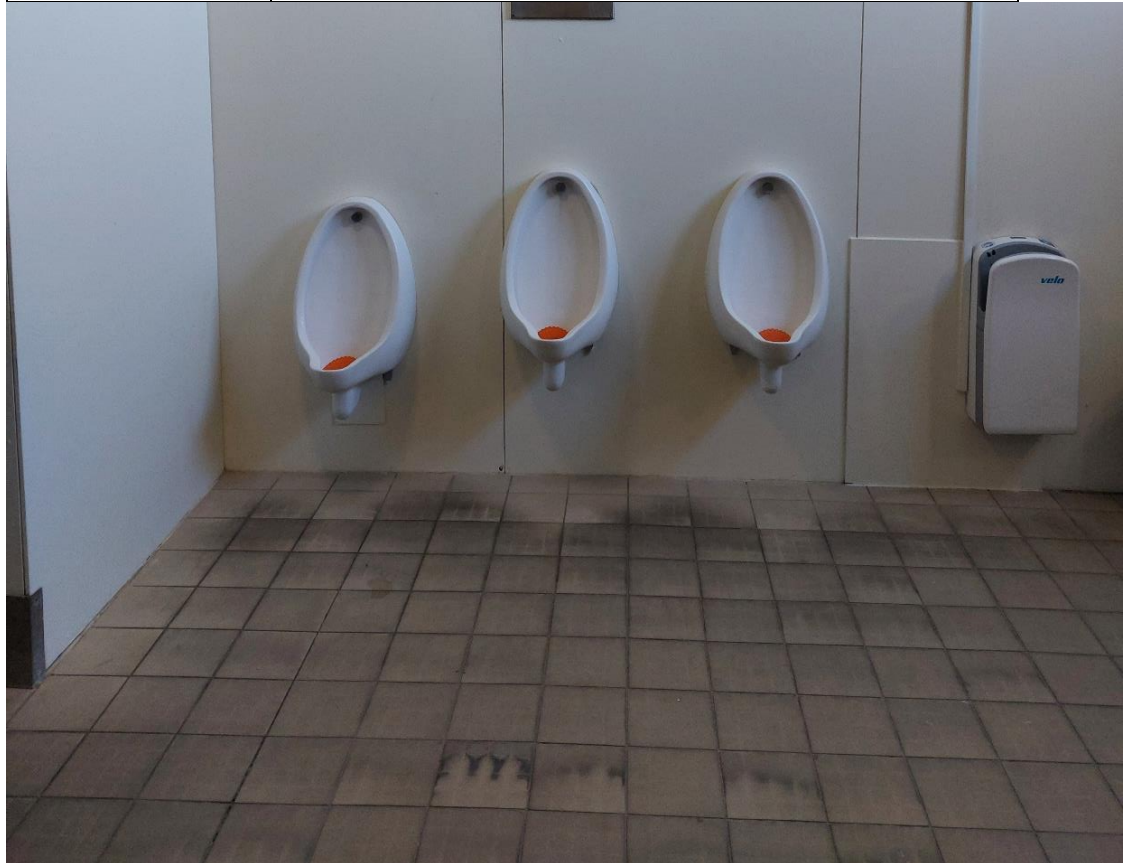
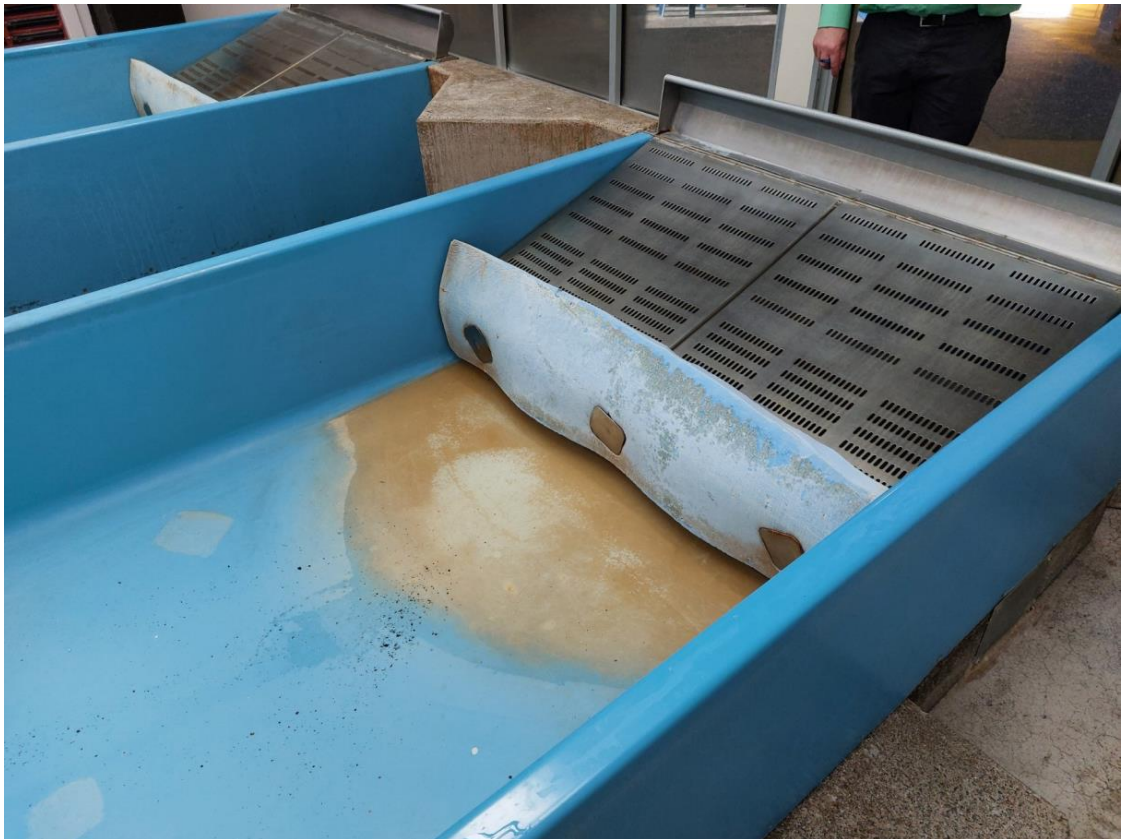
Update Ivan Wilson

Why is it required?	<ul style="list-style-type: none"> ▪ 23 year old facility in need of decent upgrade ▪ Design issues impacting operations and asset condition 	
What are the recommendations?	<ul style="list-style-type: none"> ▪ Refurbishment of male, female and family changing rooms – including flooring ▪ Incorporation of accessibility improvements from Barrier Free assessment ▪ Interior painting ▪ Acoustic ceiling panel replacement 	
How much?	Refurbishment of male, female and family changing rooms	236,515
	Interior painting	196,041
	Acoustic ceiling panel replacement	217,211
	TOTAL	649,767
Risks	<ul style="list-style-type: none"> ▪ Ceiling panels failing (again)

▪Condition of changing rooms and cladding continuing to impact customer satisfaction and lose customers
Source documents	NCC NAC Refurbishment Options: Elemental Cost Estimate – Dean & Quane (Aug 2021)

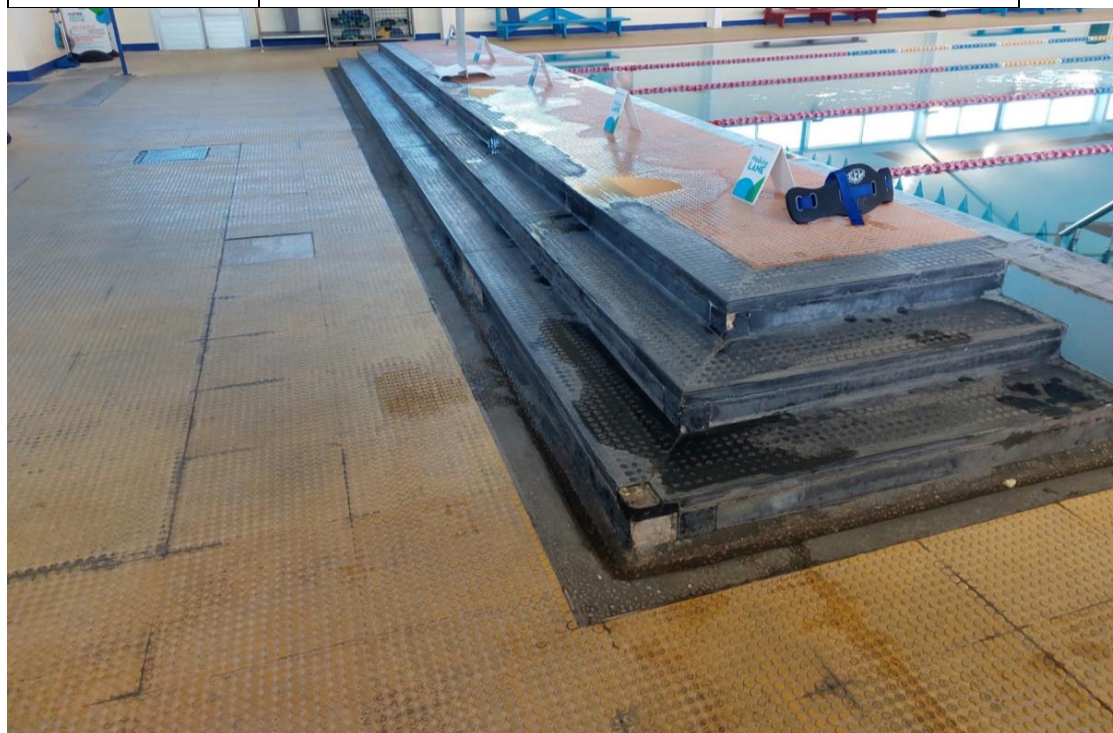
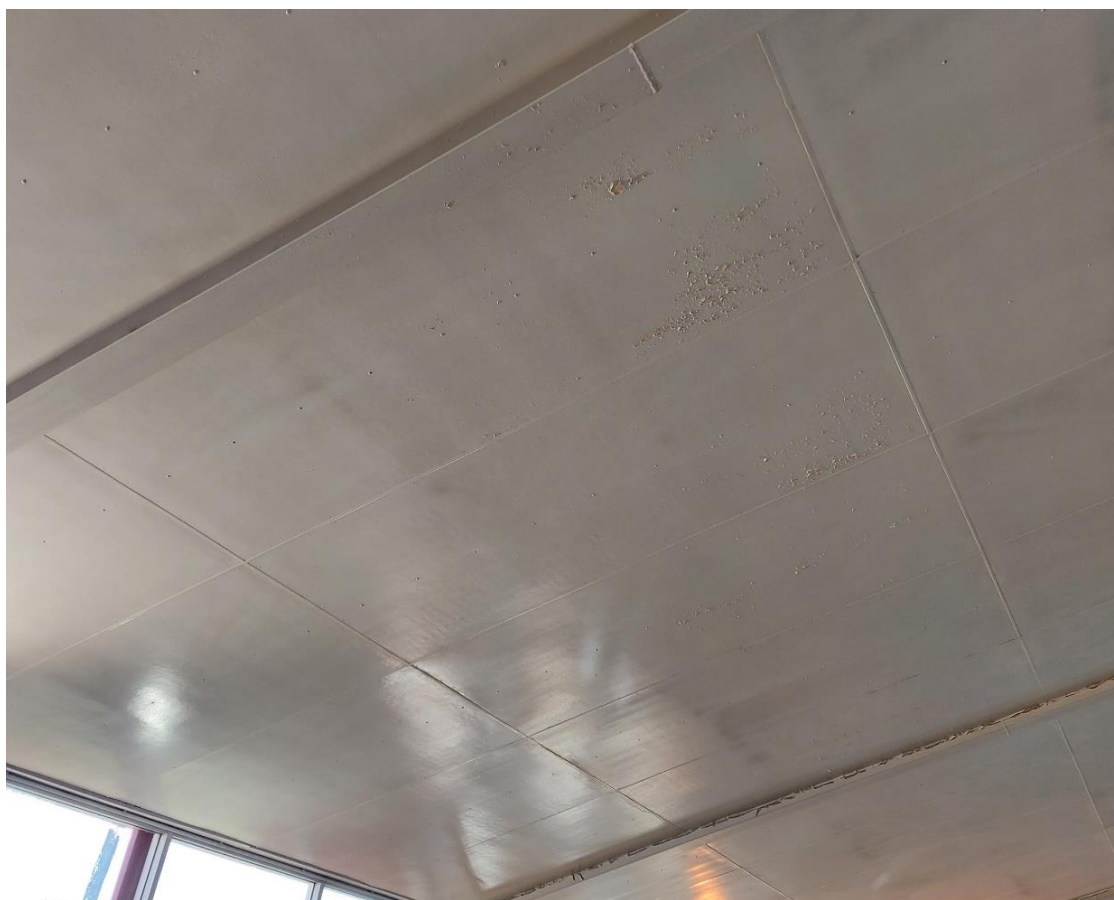
Update Old Pool

Why is it required?	<ul style="list-style-type: none"> ▪ Pool at end of life and in very poor condition ▪ Safety concerns with asbestos cladding ▪ Terrible acoustics making teaching environment difficult and impacting 	
What are the recommendations ?	<ul style="list-style-type: none"> ▪ Refurbishment of male and female changing rooms ▪ Asbestos ceiling replacement ▪ Interior painting ▪ Flooring replacement – pool concourse ▪ Acoustic improvements 	
How much?	Refurbishment of male and female changing rooms	149,976
	Asbestos ceiling replacement	311,983
	Interior painting	50,371
	Flooring replacement	85,503
	TOTAL	597,833

Risks	<ul style="list-style-type: none">▪Asbestos condition deteriorating causing risk to customers and team▪Poor condition of facility continuing to impact customer experience and visitation
Source documents	NCC NAC Refurbishment Options: Elemental Cost Estimate – Dean & Quane (Aug 2021)

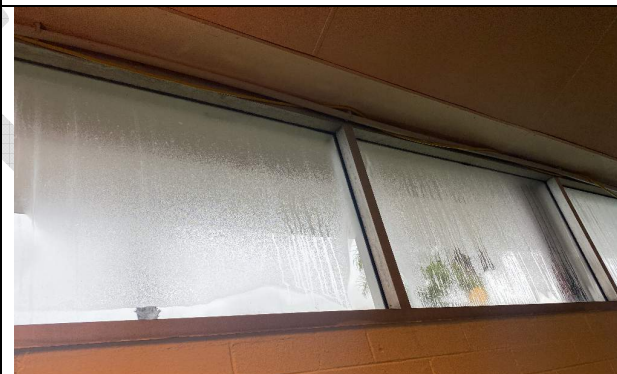
Item	2014 Report	2021 Inspection Findings	
3.	Windows and Doors		
	<i>Windows comprise a non-thermally broken, single glazed commercial suite more suited to shop front purposes. As noted previously, they are unsuitable for use in a modern pool facility.</i>	Condensation was noted on the inside of windows, due to the cooler exterior conditions and the warm humid indoor conditions. While unsightly, this is not a long term durability issue. Refer general comments below on building envelope and energy efficiency.

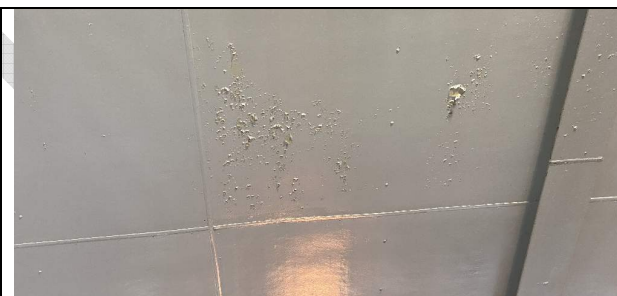
4	Ceilings		
	<i>The painted Hardiflex ceiling within the pool hall was in generally good condition. There were no signs of staining as a result of water (leaks and/or condensation) The pool hall was noted as having poor acoustics, and the HVAC plant was particularly noisy. It was noted that the hardiflex sheets were sealed with silicone sealant to the portal frames and that this junction had subsequently been painted over. This has led to unsightly peeling of the paint at this junction. (refer photo above)</i>	<p>The Hardiflex ceiling was in generally good condition, with some flaking noted to paint coatings.</p> <p>The silicone sealant to the portal frame has paint peeling as was noted in the previous report. In the absence of an impervious vapour barrier and minimal insulation, the ceiling and how it is sealed to adjacent structure takes on added importance as a first line of defence for chloramine laden air getting into the ceiling cavity. If this pool air is able to enter the ceiling cavity, it can be expected that condensation will form on the underside of the roofing and affect the durability of building fabric within this space.</p> <p>Refer to comments below on the roof and supporting structure.</p>

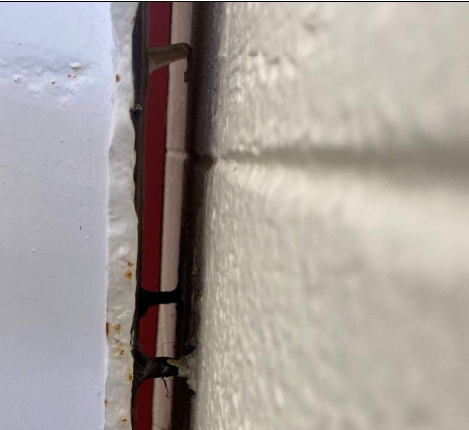
7.	<p>Changerooms</p> <p><i>Change rooms are of simple robust construction with painted concrete block walls, painted fibre cement ceilings in pvc jointers and concrete floor finished with what appears to be an acrylic plaster coating.</i></p> <p><i>There were no signs of physical degradation of a significant nature. However, we did note that plaster floor coatings are failing at gutters near the whb and in the showers. There were a number of locations on the changeroom ceiling where paint was peeling in patches.</i></p>	<p>Unchanged from previous inspection;</p> <ul style="list-style-type: none"> • Ceiling paint finish flaking. • Block walls are in good condition and appear to have been painted recently. • Noted that the space between the column and the block wall (as pictured) is unfilled, and there is degradation noted to the ties between the column and the wall. Refer BECA Comment below.

<p>BECA (Murray Chalmers) Comment;</p> <ul style="list-style-type: none"> • <i>The corrosion to the U-Bolt connections between the columns and change room block walls was identified as an issue in Section 2.2 of the initial April 2015 DSA. It was again highlighted in Notes following the Summary of Findings the August 2021 update as follows:</i> <p><i>Notes:</i></p> <ul style="list-style-type: none"> • <i>The portal leg/masonry wall connection was assessed at 55% being governed by the shear capacity of the U-bolt ties. However, there was one connection that was badly corroded and was assessed at 20%. The score of the portal/masonry wall connection was scaled down from 55% to 40% to compensate for the corroded connection. If this corroded connection is replaced, the score for the portal/masonry wall will be 55%.</i> • <i>The capacity of the U-Bolts is the governing factor limiting the overall score for the Old Lap Pool Building to 40%NBS.</i> • <i>Consequently, remedial work is required and these U-Bolt connections should be upgraded or replaced.</i>

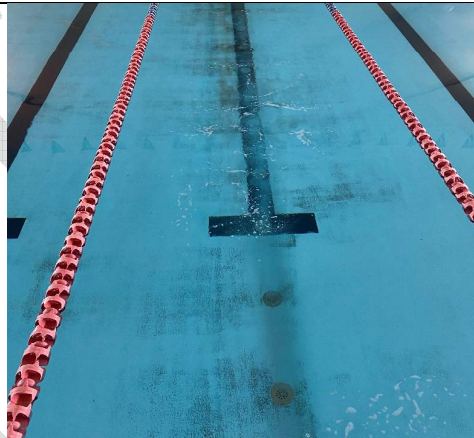
Item	2014 Report	2021 Inspection Findings	
8.	Pool Tank		
	<p>The lanes are approx. 2.15M wide and the pool depth is nominally 1.05M to 1.1M. Pool paint finishes are in worn condition. We understand that the pool was painted approx. 3 years ago, and repainting is required in the next year, along with the replacement of construction joint sealant. A stainless steel nosing has been installed to the long sides of the pool. This nosing is slightly out of level and has little slip resistance. The level discrepancy is not considered a major issue, but equally could be readily corrected by packing the stainless steel channel in order that even flow is experienced into the roll out channels. Tiles to the top of the balance tank, ribs and steps are well worn and in generally unsightly in appearance.</p>	<p>The condition of the pool tank appears to be unchanged from the previous inspection. The previous inspection noted that the pool was to be repainted in 2015.</p> <ul style="list-style-type: none"> Pool paint finishes are significantly worn, and the pool requires repainting. The long term durability of the concrete may be affected if left unpainted. It is not clear whether the stainless steel pool edge level has been corrected, however there was no noticeable level difference. The pool tank appears to be a single large tank, with no movement control joints visible.

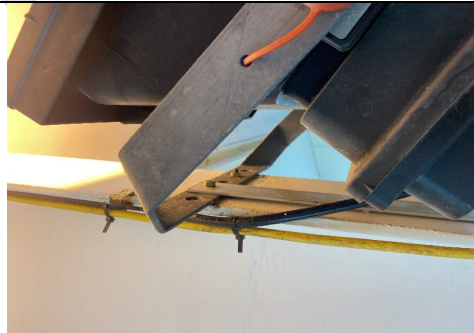
9.	Secondary Fixings (lights, HVAC ducts etc)		
	<p>Not inspected in 2014.</p>	<p>In recent years, there has been an increasing awareness the risk of secondary fixings supporting elements such as lights, speakers and HVAC ducts pose. A limited inspection (where possible) of light fitting fixings was undertaken, and these appeared sound. It is worth noting that as these are mounted on the column face they are not directly above circulation routes and therefore represent a reduced risk to patrons. Access was not possible to HVAC duct supports. We recommend that these supports and fixings be inspected on a 5-7 year basis.</p>

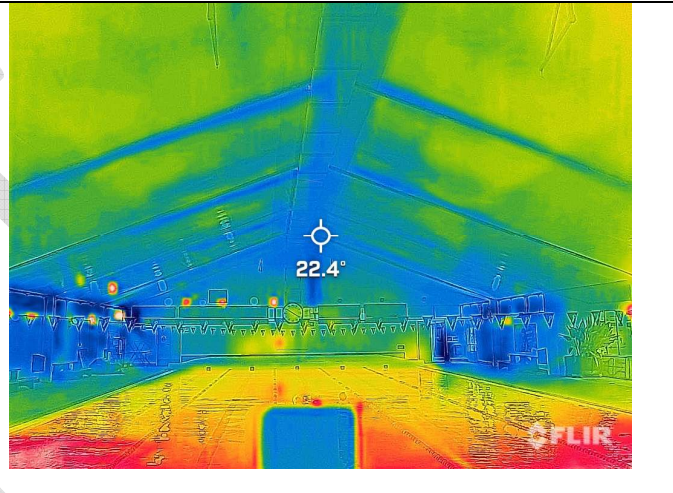
10.	<p>Generally A FLIR infrared camera was used to assess the thermal performance of the building fabric. Refer adjacent photo.</p> <p>The blue (colder) areas indicate where condensation is likely to form first. The entire pool hall has minimal insulation, with only 25mm thick of EPS sheet in the ceiling/roof cavity. The lack of insulation has two consequences;</p> <ul style="list-style-type: none"> • The building fabric is highly inefficient, and is likely to use significantly more energy to heat than a modern building of the same type. • The lack of insulation and an effective vapour barrier promotes condensation during colder outside conditions. This chloramine laden condensation is corrosive and contributes to deterioration of the building fabric. <p>It is worth noting that the new H1/AS2 Energy Efficiency requirements will become mandatory from November 2022. If these requirements were to be applied to the current building, a minimum R value (thermal resistance) of 4.0 for the roof would be required (compared with approximately R0.60 in the current construction). An R value of 2.4 would be required in the walls, compared with approximately 0.18 currently. These increased thermal requirements mean that the only effective method of achieving these values would be the use of insulated panels such as Kingspan high humidity panels.</p>

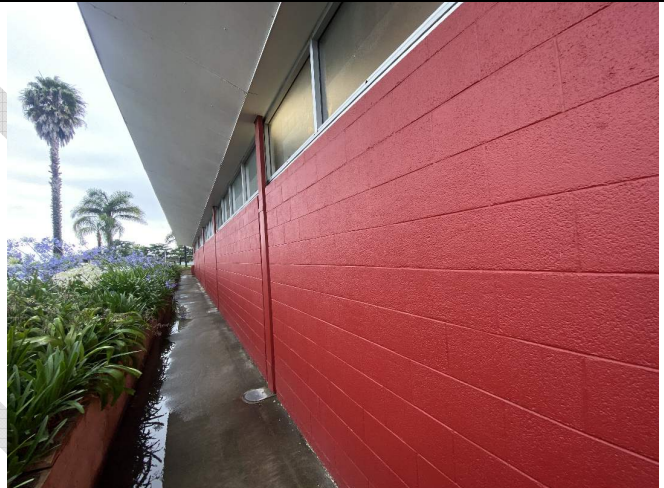
Item	2014 Report	2021 Inspection Findings	
B	POOL HALL EXTERIOR		
1	Masonry Walls		
	<p><i>Some fading of the paint has occurred, but generally masonry walls are in good condition. It is recommended that when these walls get repainted, they be painted in a lighter colour to reduce the thermal stress on the paint finish.</i></p>	<p>Masonry walls are in good condition, and appear to be have been recently repainted. As noted in the 2014 report, a lighter colour may have greater durability and reduced maintenance requirements.</p>

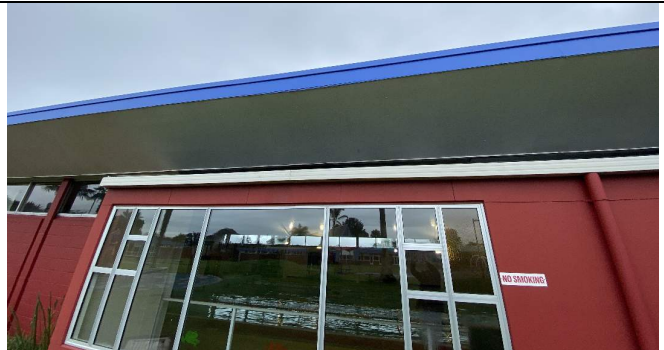
2.	Fibre Cement Walls		
	<p><i>Fibre cement cladding appears to be direct fixed to the framing, and is painted to match the adjacent masonry walls. Sheet fixings are clearly broadcast on the exterior of the sheet. The condition of the paint is as for the masonry walls, and when next painted this cladding would be best painted in a textured, light coloured waterproofing product such as Resene Thixalon.</i></p>	<p>No change to the 2014 report, noting that it appears that the fibre cement cladding has been repainted.</p>

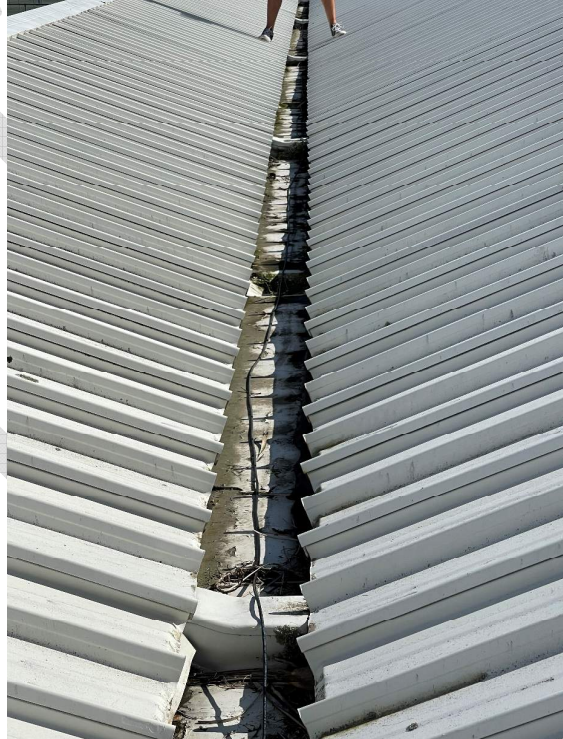
Item	2014 Report	2021 Inspection Findings	
3.	Roof		
	<p><i>The profiled metal roofing and associated roof fixings are in good condition.</i></p> <p><i>The membrane gutters are in poor condition. Sides of the membrane gutter have come loose in places, seriously affecting the integrity of the gutter. There is no sign on the interior of the building of it having leaked to date. New leafguards are required to protect downpipe positions from blocking due to accumulated leaves.</i></p>	<p>The roof was not inspected. The Tufrey Report dated 2nd September 2021 was reviewed. It is not known whether any of the work identified in the Tufrey report has been undertaken.</p> <p>The report identifies a number of issues identified in earlier reports that require attention;</p> <ul style="list-style-type: none"> • Membrane gutters in poor condition, with poor membrane adhesion to substrate and membrane material failure. • Significantly, it is noted that gutter capacity is undersized. • Membranes gutters are full of debris and require cleaning. • It was noted during the visit that there were two locations where leaking had occurred following heavy rain from the previous evening. One of these locations corresponds with the location identified in the Tufrey report. • Some corrosion to roof sheets.

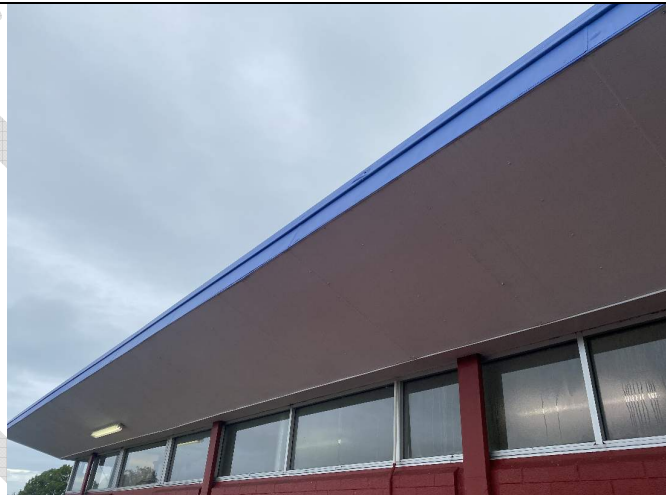
Item	2014 Report	2021 Inspection Findings	
4.	Soffits & Fascia		
	<i>A small amount of paint bubbling was noted on the fascia.</i>	<p>The dark blue fascia has a number of bubbles in it, as noted previously.</p> <p>Soffit lining has a textured finish and expressed fixings. The soffit is in generally good condition, with a few minor cracks which will not significantly affect the weathertightness or durability of the building.</p>

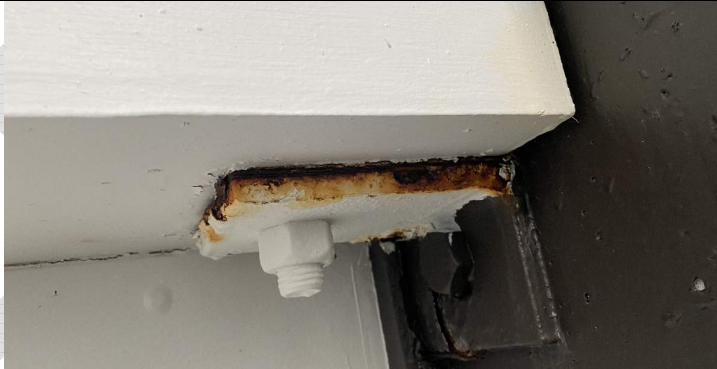
C	IVAN WILSON BUILDING	
1.	<p>Hydroslide Area Bracket</p> <p>Advise from BECA (Murray Chalmers) as follows; <i>Girt Bracket to Hydro Slide</i></p> <ul style="list-style-type: none"> - Similar to the column bases, on the evidence of the photos provided, it does not appear that the extent of corrosion has reached a point where it would result in a significant reduction in the structural capacity of the bracket. - Remedial work is required, which should include the following: <ul style="list-style-type: none"> i. Remove loose rust to base plates and hold down bolts back to bright metal or original galvanised coating if present. ii. Treat brackets and bolts with rust neutralizer, prime with zinc rich paint, and paint repairs to match existing. Replace bolts if easier option. iii. If severe corrosion is found during the remedial work, indicating a substantial loss in steel area of any component, Beca should be advised.

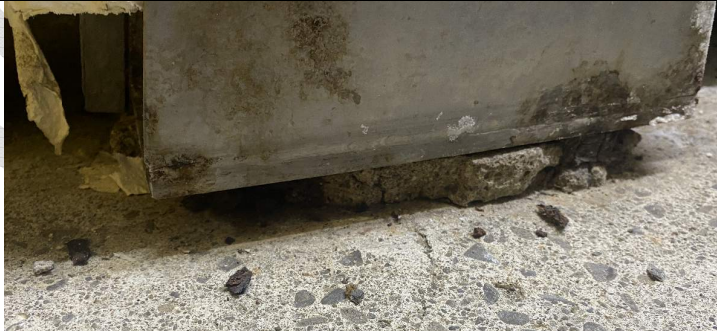
2.	<p>Plant Room Column Base</p> <p>Advise from BECA (Murray Chalmers) as follows; <i>From the photos, it would appear similar remedial work to that outlined above for the Old Lap Pool is required.</i></p> <ul style="list-style-type: none"> i. Breakout and remove mortar packing under base plates back to sound mortar. Provide temporary shims to support columns if required. ii. Remove loose rust to base plates and hold down bolts back to bright metal or original galvanised coating if present. iii. Treat base plates and hold down bolts with rust neutralizer, prime with zinc rich paint, and paint repairs to match existing. iv. Repack mortar beneath base plates. v. If severe corrosion is found during the remedial work, indicating a substantial loss in steel area of any component, Beca should be advised.

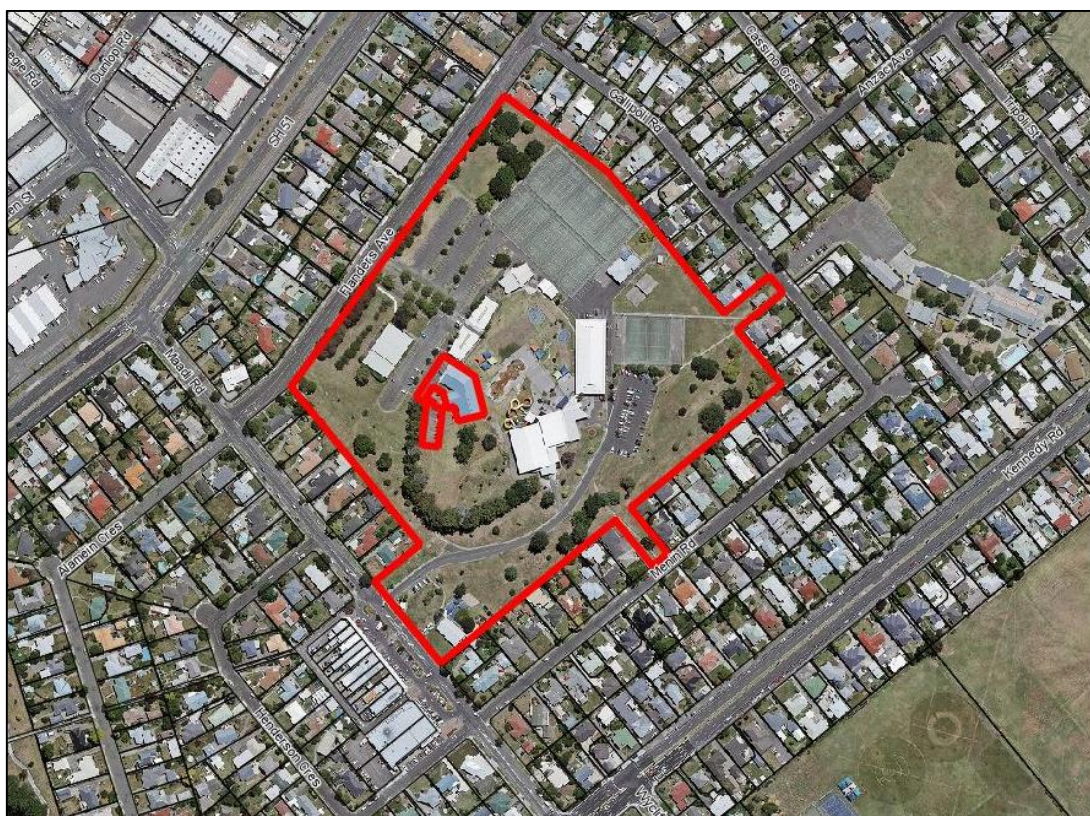
Figure 2: Site

The site (the Park) is located at 27 Maadi Road. Referred to as Onekawa Park, it is zoned Sports Park in the City of Napier District Plan.

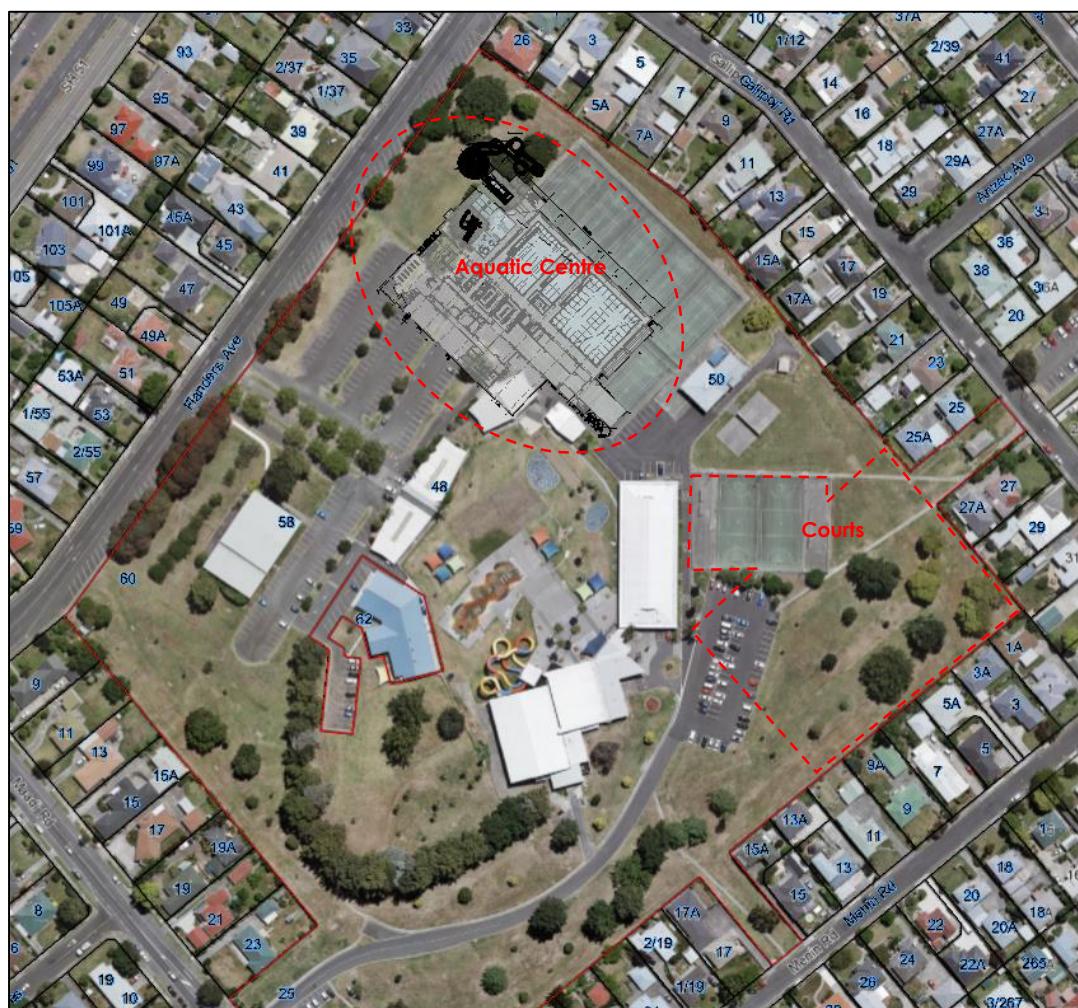
Figure 4: Option 1

Option 1 involves the establishment of an aquatic centre as generally described in Section 3.1 in the north-west corner of the Park with the relocation/re-establishment of the existing courts to/in the eastern corner of the Park as shown in **Figure 4** below. Specific to Option 1, and in addition to the details outlined in Section 3.1:

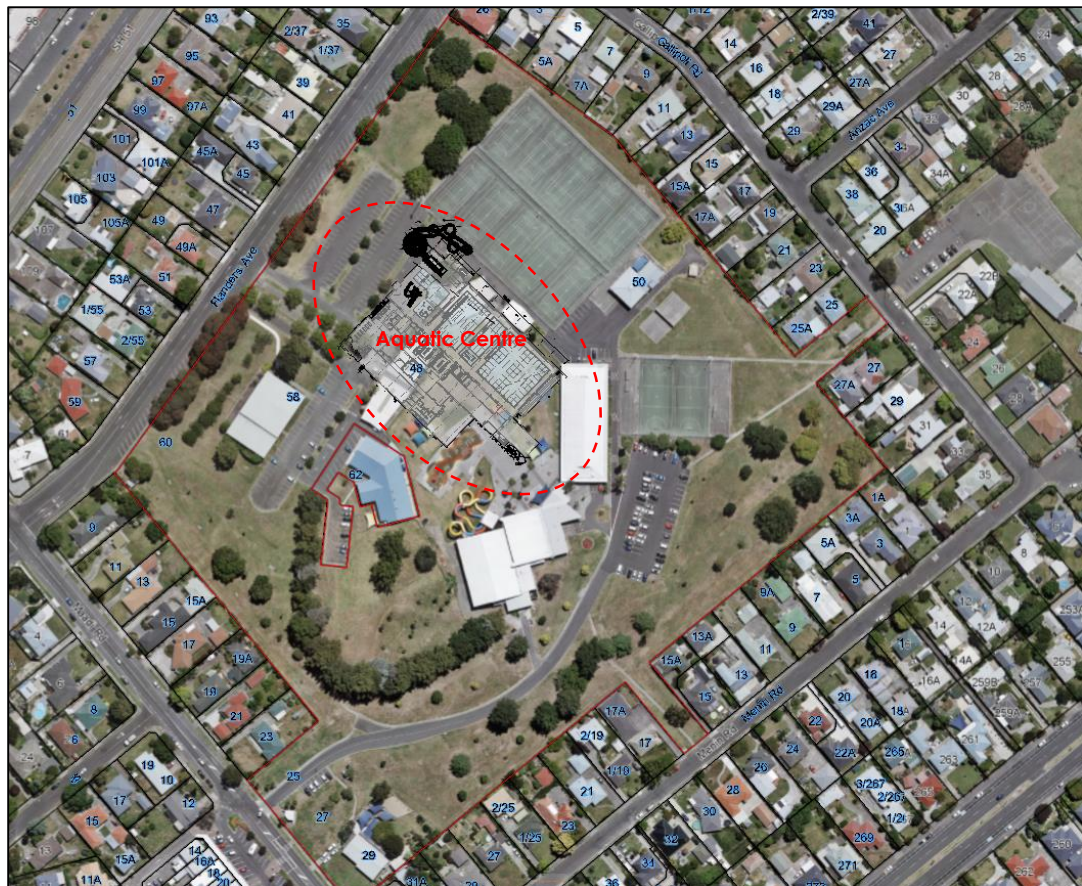
Figure 5: Option 3

Option 3 involves the establishment of an aquatic centre as generally described in Section 3.1 in a central location within the Park as shown in **Figure 5** below. Specific to Option 3, and in addition to the details outlined in Section 3.1:

- residential boundaries (along Flanders Avenue and Gallipoli Road),
- The building/hydro slides are anticipated to be set back circa 50-60m from the closest boundaries with regard to height in relation boundary controls.

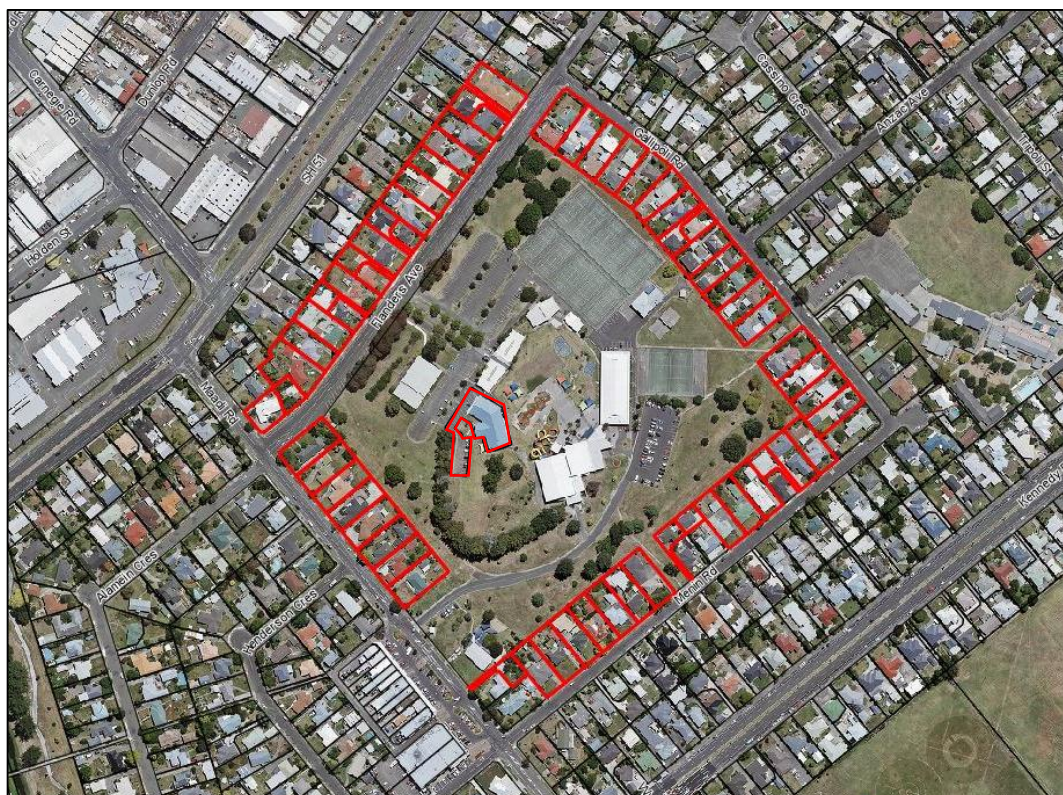
Figure 6:

Here Section 95D(a) states effects must be disregarded on persons who own or occupy land upon which the activity will occur or land adjacent to that land. The land presumed to be disregarded in accordance with Section 95D(a) is shown in **Figure 6** below.

Step 3 essentially requires the Consent Authority to determine whether a person is an affected person in accordance with section 95E, which generally involves returning to the parties disregarded under Section 95A – which for the purpose of this analysis are assumed to be those shown in **Figure 6** above. To be found affected under Step 3, the activity's adverse effects on the person must be considered minor or more than minor (but are not less than minor). Relevantly, Section 95E(2)(a) states the consent authority may disregard an adverse effect of the activity on the person if a rule permits an activity with that effect – such as the exemption of noise arising from sporting events in relation to the effects of the courts under Option 1.
